Socio-environmental impacts of landfill site in Nduba sector, Kigali, Rwanda

Alain Nkomezi, Francine Uwimbabazi, Chunho Yeom

Abstract. *Currently, solid disposal is a significant challenge in urban cities. In particular, Kigali City generates thousands of tons of solid waste to be transported and discarded in one city's landfill on a daily basis. It has contributed to the rise of social and environmental problems near the Nduba landfill. Previous studies have emphasized types of waste (liquid and solid) but have been unable to demonstrate land use and cover change because of solid waste disposal since its establishment in 2012. The study aimed to evaluate spatiotemporal changes vis a vis the social and environmental implications of solid waste disposal in the Nduba sector. Primary data were collected within a defined study area, whereas secondary data relied on remote sensing and geographic information system (GIS) data. Images of land use/cover were used for spatial analysis and changes before and after landfill establishment. The findings of this study indicate that land use/cover has changed considerably in the last decade. For instance, the built-up area increased within the

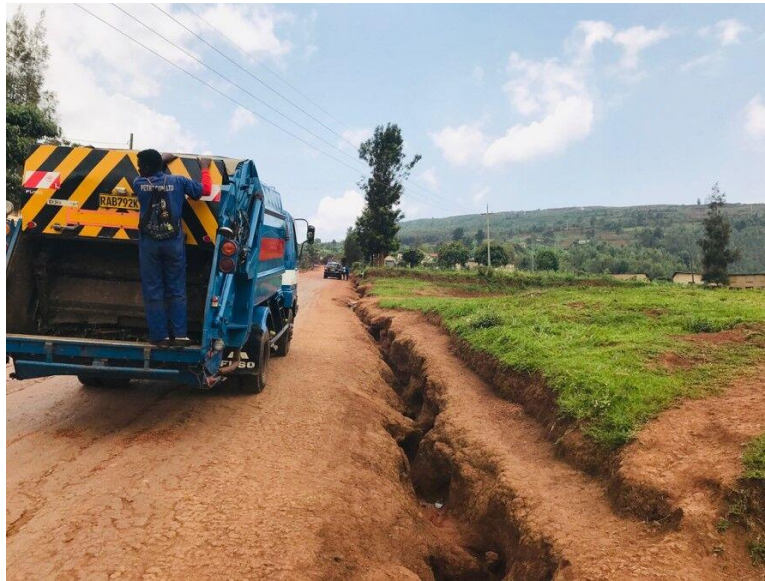
Figure 8: Garbage truck transporting solid waste to the Nduba landfill site

Each waste truck took one main road passing through the Gasanze center to the Nduba landfill. A road with a width of 5 to 6 m is insufficient to allow a smooth flow of trucks and other vehicles. It has been reported that during heavy rainy seasons, some company vehicles, particularly those in old conditions, cannot be used because of poor road conditions. Another concern of the road is the heavy dust blown out toward housing units alongside the roads. Inadequate roads and safety are other concerns for pedestrians and Nduba residents. One of the interviewees stated that a number of accidents occurred because of the absence of road enforcement regulations and a lack of improved road conditions. No road accessing the site had a sewage system, as shown in Figure 9 below.

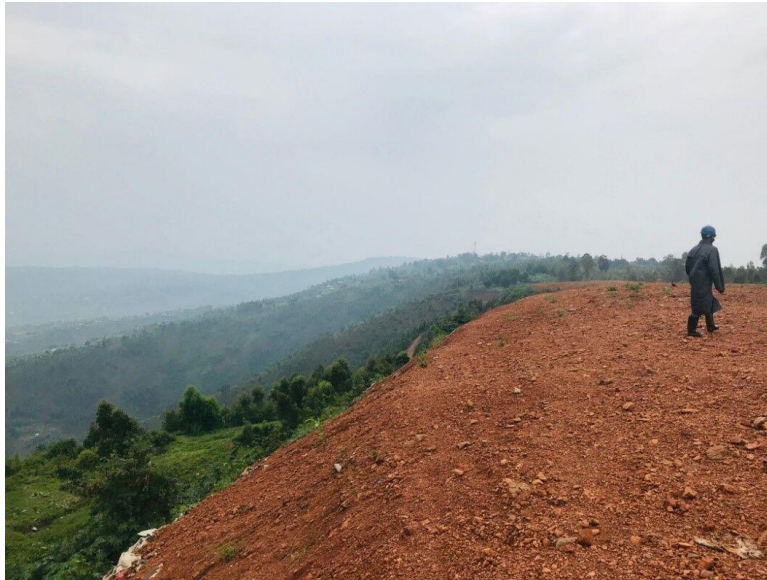
Water sources were identified in the surroundings of the site. These elements present the potential and uniqueness of an area for mitigating environmental impacts. Several trees were identified near the site, and the distance from the site was ≤ 20 m. Respondents argued that old trees used as traditional medicine were cut off during site extension from 2014 to 2016 (Figure 10).

Figure 9: Trees and grassland surrounding the site

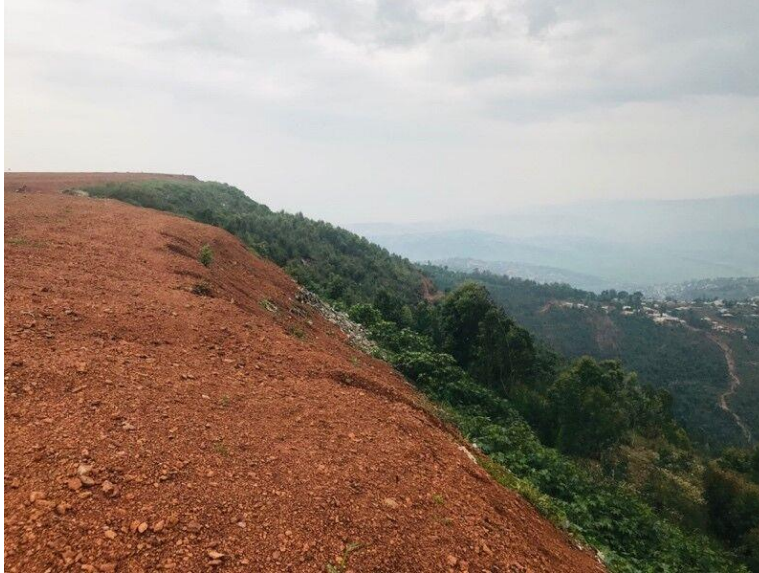
Figure 11: Layer of laterite soil covering the solid waste

The interviewees located on the western side of the landfill urged that the situation became unhealthier during the rainy season. Those identified were found in the Gasanze and Gatunga cells. Water runoff often carries solid waste from a site to its neighborhood. Precipitation also presents other challenges for accelerating waste leakage toward residential compounds. Despite this concern, landfills have no retaining facilities to block solid waste leakage and other materials (Figure 12). The sloping terrain of the view side of the Gasanze and Gatunga cells is steep compared with any other side of the landfill. During the rainy period, the soil covering the dumped material could slide downward, leaving garbage uncovered.

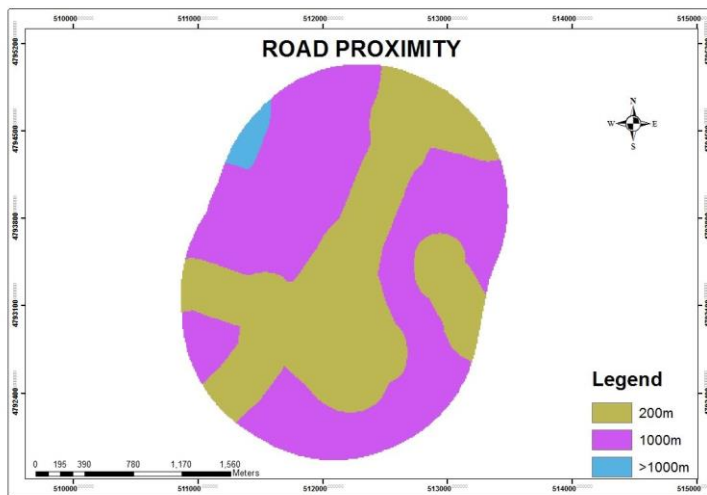
Figure 14: Suitability analysis of the road vis-à-vis the landfill

Different spatial criteria were investigated to determine the suitability of the site. The spatial attributes presented in Table 1 were used with weighted overlay methods. The produced suitability maps reveal the interconnection between criteria ranging from unsuitable to most suitable within the study area (Figures 13 through 16). The findings showed that almost the entire site boundary was located in the least suitable area. However, additional attributes could be important for the analysis and indicate that the site is not suitable for its location.
